Bioventing at Operable Units 5, 8, 9, 10, and 11

Loring Air Force Base SEMIANNUAL PERFORMANCE REPORT August — December 1997

March 1998 Revision B

Prepared by:
Bechtel Environmental, Inc.
151 Lafayette Drive
Oak Ridge, Tennessee 37830

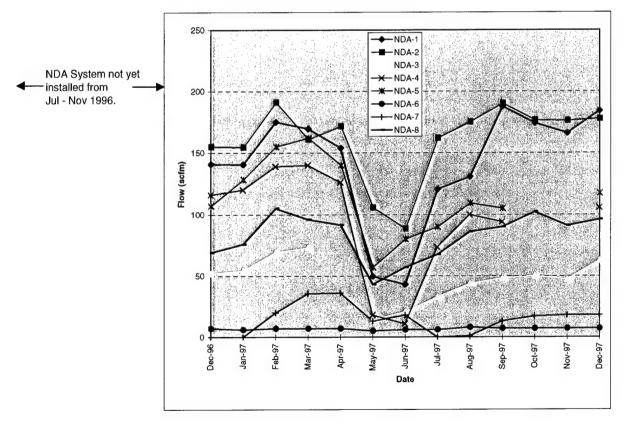
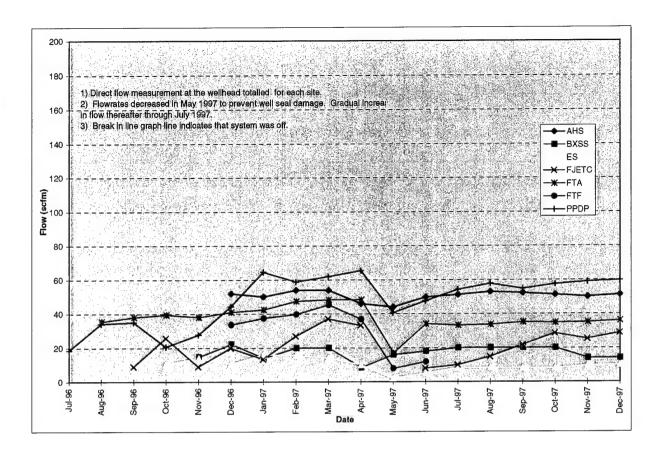
Figure 3-1 Monthly Air Flow

Figure 3-1 plots total monthly air flow at each site since startup. In general, there was a midyear downturn in monthly total flow at each system in 1997, related primarily to the wet weather that spring. Numerous NDA AIWs not performing, as noted in the last semiannual report, were again noted during the second half of 1997. NDAs 1, 3, 4, 7, and 8 continued to have nonfunctional AIWs, but several AIWs in these areas started functioning as designed. Further discussion of this is included in site specific sections presented later in this report.

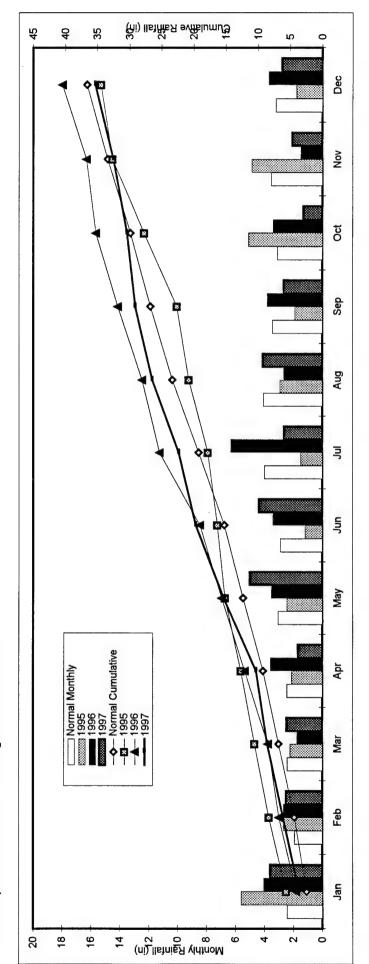
Figure 3-3 Daily and Cumulative Rainfall Amounts

Table 3-3 tabulates rainfall data recorded at the weather station in Caribou, Maine, over the past year, and Figure 3-3 illustrates daily totals and cumulative values for the past 3 years. The graph clearly shows that precipitation during April through September 1996 and 1997 have exceeded normal levels. Combined with snowmelt, these high levels may have had an impact on several of the biovent systems as noted in the last semiannual report. Saturated soils have caused air injection rates to be lower than design flow, and several MPs were affected by saturation levels, resulting in reduction of monitoring data. Rainfall amounts from October through December were close to normal. Most inundated wells noted in June and July were either only partially inundated or were not inundated from August through December, primarily due to the decrease in infiltration. Although several wells dried up, partially saturated soils did not allow air flow in several AIWs.

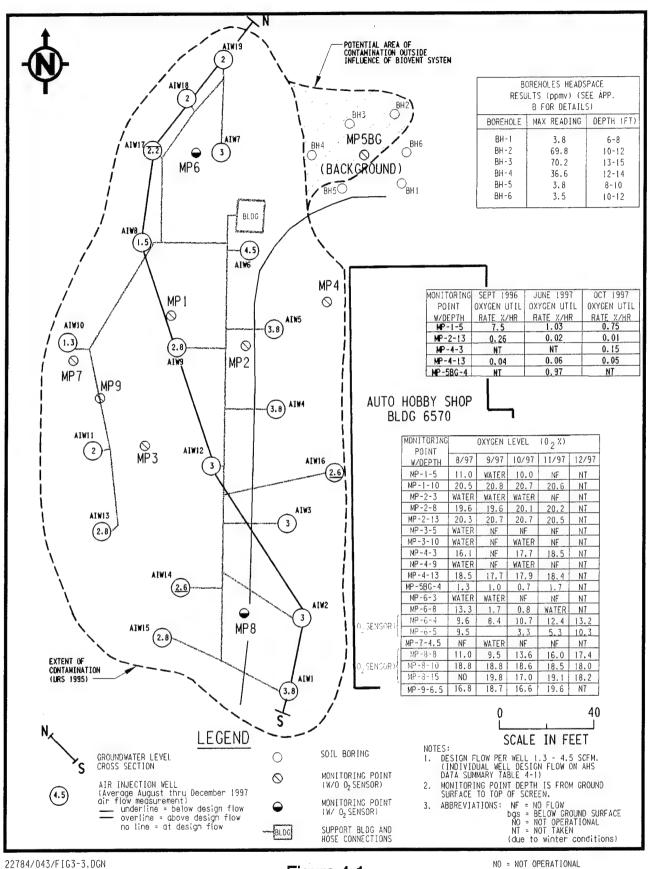
Figure 4-1 AHS Biovent System Layout and Average Wellhead Flow

Respiration tests performed on October 22, 1997 included four MPs, one of which was a new location not previously tested. Respiration data and results for the respiration tests are shown on Figures A-1 and A-2 (Appendix A). MP 5, tested in the summer, was not tested this time. MPs 2-13 and 4-13 showed results similar to the summer respiration rates; both were at background levels, indicating that biodegradation may be complete. The oxygen utilization rate at MP 1-5 decreased from 1.03 percent/hour in June to 0.75 percent in October—a significant decrease, although still indicative of active biodegradation. An additional MP (MP-9-6.5) was constructed in August.

Overall Recommendation for AHS: Most of the site is operating per design, and most MPs are providing data. No significant operational changes to the air flow settings or improvements to MPs are recommended for the AHS site at this time. Oxygen levels are below 6 percent at MP-5 and MP-6, and the oxygen utilization rate at MP-1 is 0.75 percent/hour. Therefore, the system should remain in operation until all areas of the site reflect background conditions. The distance to the potentially contaminated soils near MP-5BG is beyond the radius of influence of the nearest AIWs; therefore, a new AIW is recommended to be added near boreholes 2, 3, and 4 (Figure 4-1).

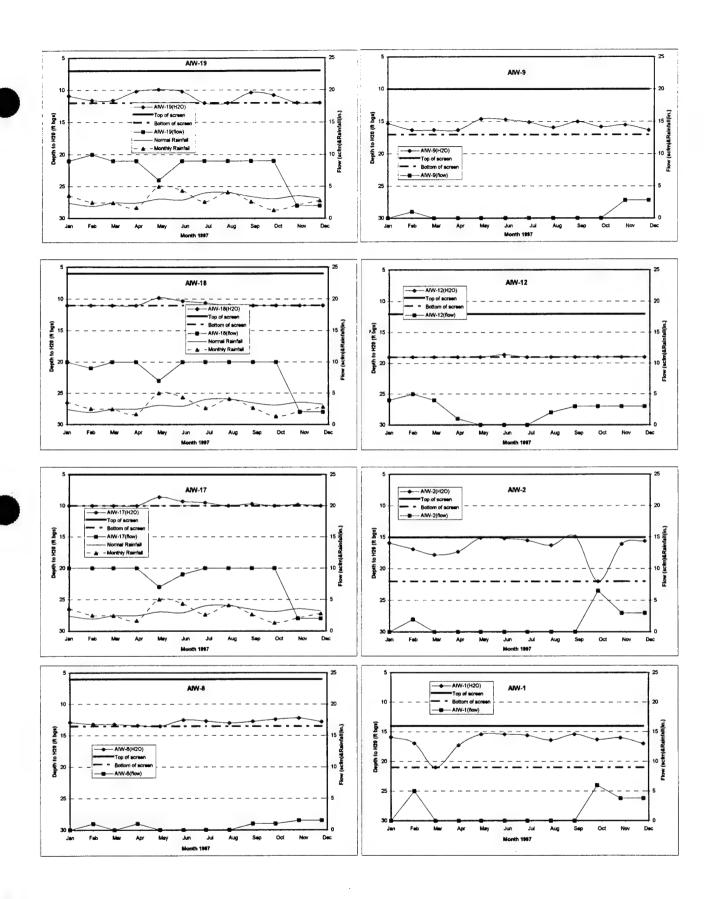
Figure 4-2 AHS Groundwater/Air Flow Relations Along North/South Section

Table 4-2 presents the monthly AIW groundwater data including a graph showing the August, October, and December groundwater levels in the AIWs located along the north-south section identified on Figure 4-1. It is evident that groundwater saturation at the AHS was not a problem; only AIW-1 and AIW-2 had groundwater levels approaching the top of the screen. Figure 4-2 presents monthly groundwater levels and air injection rates along the north-south transect for 1997. Monthly and normal rainfall totals have been added for correlation with the water and air data. All screens remained fully open except AIW-1 and AIW-2, both located at the south end of the AHS.

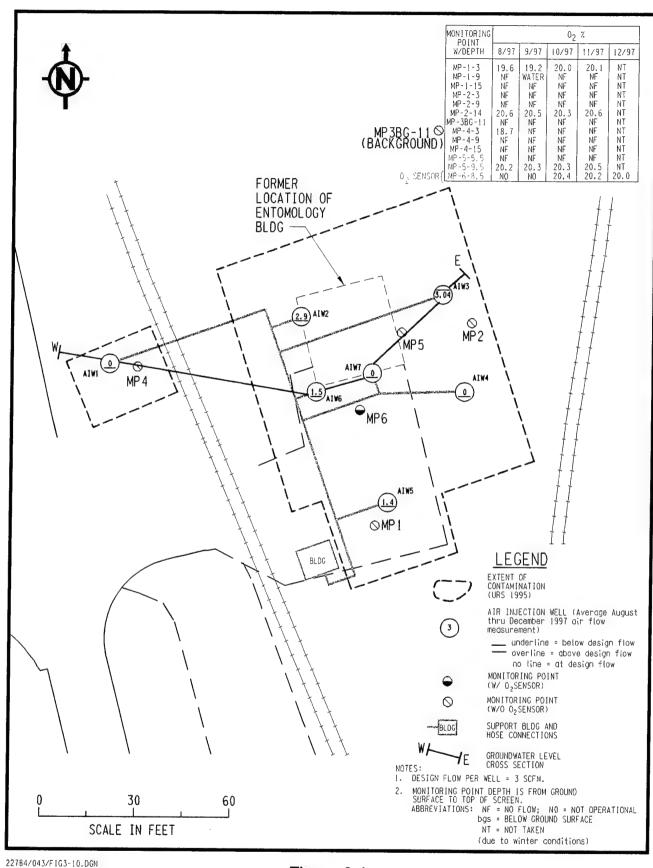
Figure 6-1 ES Biovent System Layout and Average Wellhead Flow

the MPs ineffective, a better understanding of the groundwater table is needed to evaluate any further remedial actions. If contamination still exists under the basement, the options of additional AIWs, excavation, or no action will be evaluated. Based on AIW oxygen levels, soils away from the former basement appear to be approaching cleanup goals. If soil sampling indicates PRGs have been achieved at the site, the bioventing system should be shut down.

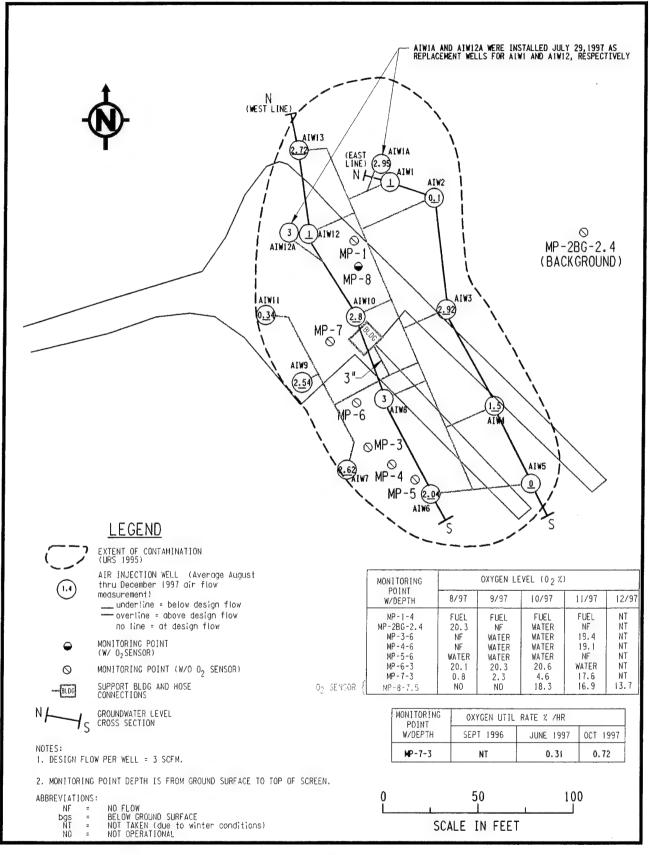
Two new replacement AIWs were drilled and installed (AIW-1A and AIW-12A) at the end of July 1997 (see Figure 7-1) to increase air flow in the northern end of FJETC. The two new AIWs have worked well since their startup in November. The new oxygen sensor (MP-8) in the south-central portion of the site contained oxygen levels as low as 16.9 percent, which may indicate that biodegradation is still in process. Contamination was identified in samples collected from the MP-8 boring (headspace results ranged from 156 to 294 ppm total volatiles).

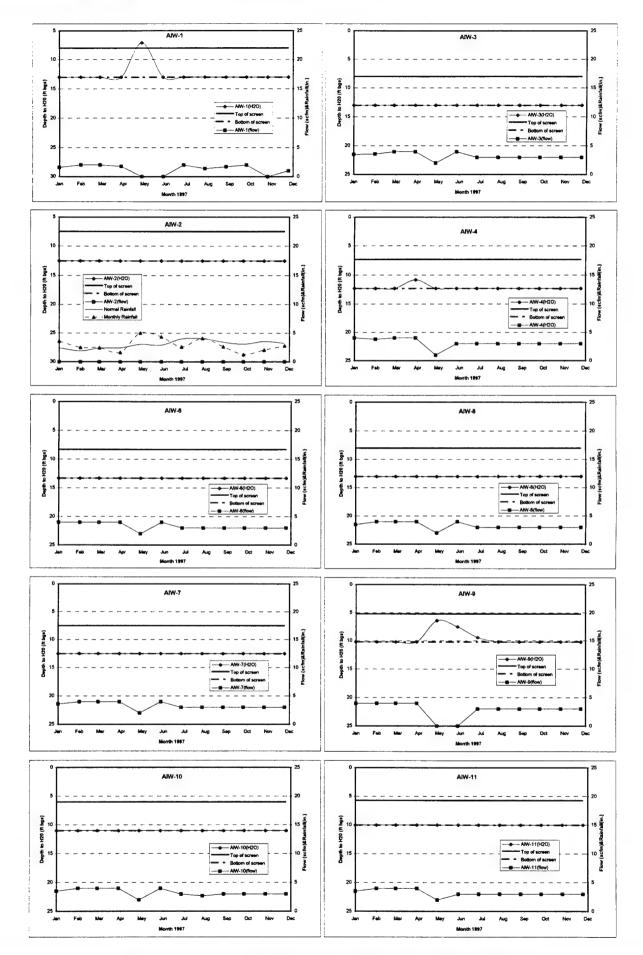
Figure 8-2 FTA Groundwater/Air Flow Relations Along North/South Section

Approximately 40 to 50 percent of the FTA MPs do not produce soil gas samples, although most of the AIWs allow air injection at design rates. Unexpectedly, most of the MPs that have no flow or saturated conditions are the 3- and 6-ft top of screen depths, not the deeper 8.5- and 10-ft depths (see Table 8-1). A perched clay/silt lens may be intersecting the shallow MPs. Table 8-2 presents groundwater levels in AIWs and a cross-sectional view of the generalized water table. It is clear that groundwater levels are not a problem at this site. On average, none of the AIWs had water greater than 1 ft above the bottom of the 5- and 6-ft screens. Figure 8-2 presents the groundwater levels and air flows per AIW along the north-south cross section on Figure 8-1. The average and normal monthly rainfall curve has been added to the first two AIW graphs for comparison to groundwater levels.

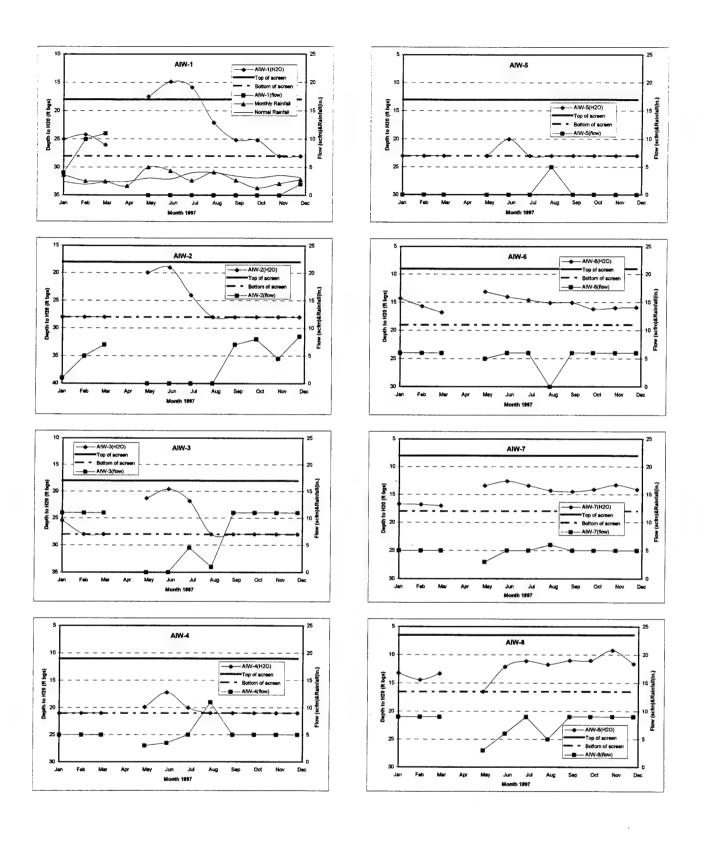
Figure 13-1 Air Flow vs. Depth to Groundwater at NDA-3

As during the last reporting period, no MP data could be collected; saturated soils around the screens (Table 13-1) prevented respiration tests from being performed. AIWs-2, 3, 4, 6, 7, 8, and 10 showed notable improvement relative to the first half of 1997. As shown on Figures 13-1 and 13-2, these AIWs were partially inundated or dry; Table 13-2 lists the 1997 groundwater levels. Most of the air flow rates were at or near the design rates. AIWs-1, 5, 9, and 11 through 21 did not show improvement from the last reporting period (first half of 1997), typically allowing zero air flow (Figure 11-1). AIWs-1, 14, and 21 were fully inundated with water during several months of 1997. Other AIWs not allowing air had minimal inundation, possibly attributable to low-permeability or saturated soils surrounding the screens. Figure 13-1 includes graphs that illustrate the fluctuating groundwater levels and air flow at all wells along the cross section presented in Figure 11-1.

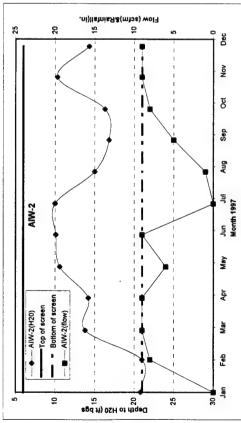
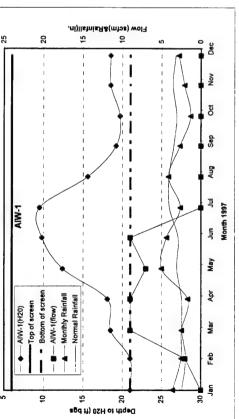
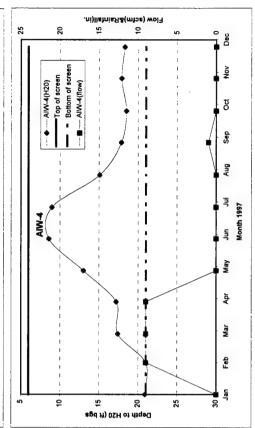
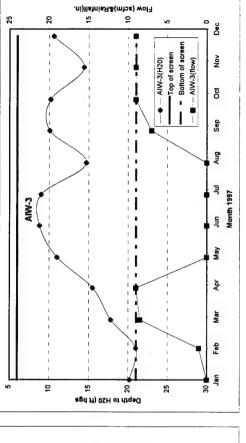
Figure 17-1 Air Flow vs. Depth to Groundwater at NDA-7

All four AIWs have been partially inundated with groundwater from February through December 1997 (Figure 17-1). Table 17-2 contains the depths to groundwater at each of the four AIWs. Between May and August, all of the AIW screens were, on average, 70 percent inundated with groundwater. The AIW-7-3 graph on Figure 17-1 shows that the monthly rainfall for May and June 1997 was well above the normal monthly precipitation totals. In general, air flow at all of the AIWs was affected at the onset of or during high groundwater levels. Both AIW-7-1 and AIW-7-2 accepted air during the warmer spring/summer months; although both had problems from July thereafter (AIW-7-2 actually recovered by October). At MP 7-2, the October and November oxygen sensor readings were 16.9 and 14.4 percent, respectively, which indicates that enhanced respiration was occurring.

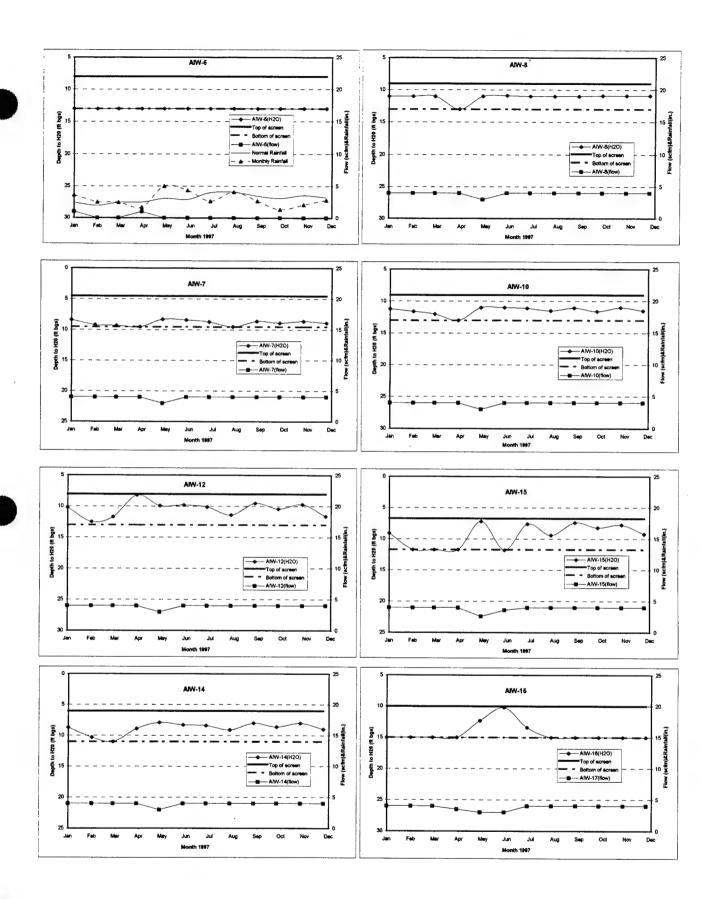
Figure 19-2 PPDP Groundwater/Air Flow Relations - Westline

In general, the contaminated area is being aerated at air flow rates equal to or below the 4 scfm design rate. AIW-6 has not accepted air since startup (except 1 scfm in April 1997). As mentioned above, air flow has not been impeded by partial inundations as illustrated on Figures 19-2 and 19-3. Low oxygen levels were recorded in MPs-3-3, MP-8-3, MP-9-3.5, MP-9-8.5, and MP-10, the only MPs with indications of active respiration (low readings of 10.9, 15.3, 10.5, 12.4, and 14.6 percent oxygen, respectively). The remaining MPs either had oxygen readings greater than 18 percent or yielded no data because of saturation/no flow.

Overall Recommendation for PPDP: No changes are recommended since the AIWs are working as planned and contaminated soils still are believed to remain, based on low oxygen readings and elevated carbon dioxide and TVH readings. Oxygen utilization rates show a general decline, likely attributable to the ongoing biodegradation. Collect soil samples throughout the PPDP beginning in June 1998.

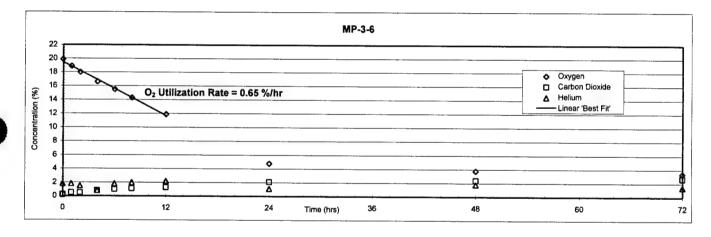
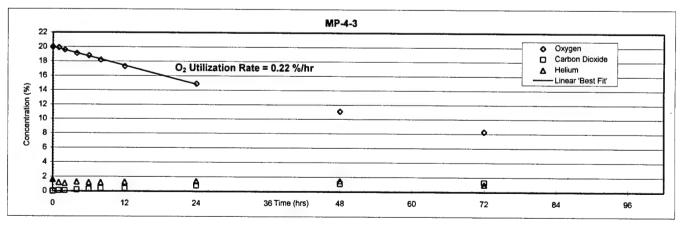
Figure A-13 Fall 1997 Respiration Test Results for MP-3-6 and MP-4-3 at the PPDP

Respiration tests were run at three of the same locations where fall respiration tests were performed including a different MP (Figures A-13 and A-14). Test results from MP 3-6 indicate an increase in the rate to the fall 1996 level (0.75 and 0.73, respectively); these levels are those expected with active biodegradation. Active biodegradation is also indicated at MP-4-3 and MP-9-8.5. Oxygen utilization at MP-6-3 has reached typical background levels (0.07 percent/hour). Elevated TVH readings were noted in MP-9-8.5 during the respiration tests (see Figure 19-3) and the monthly monitoring event (see Table 19-1). It appears that approximately 3 ft of unsaturated contaminated soils (located below the 1995 removal; see Figure 19-1) are the probable source of the volatiles. Contaminated saturated soils may exist below these unsaturated soils, thus continually providing elevated soil gas.
